# Electronic Reporting

## BS EN 12767: 2007 Impact Test

### TRL085B

# BS EN 12767: 2007

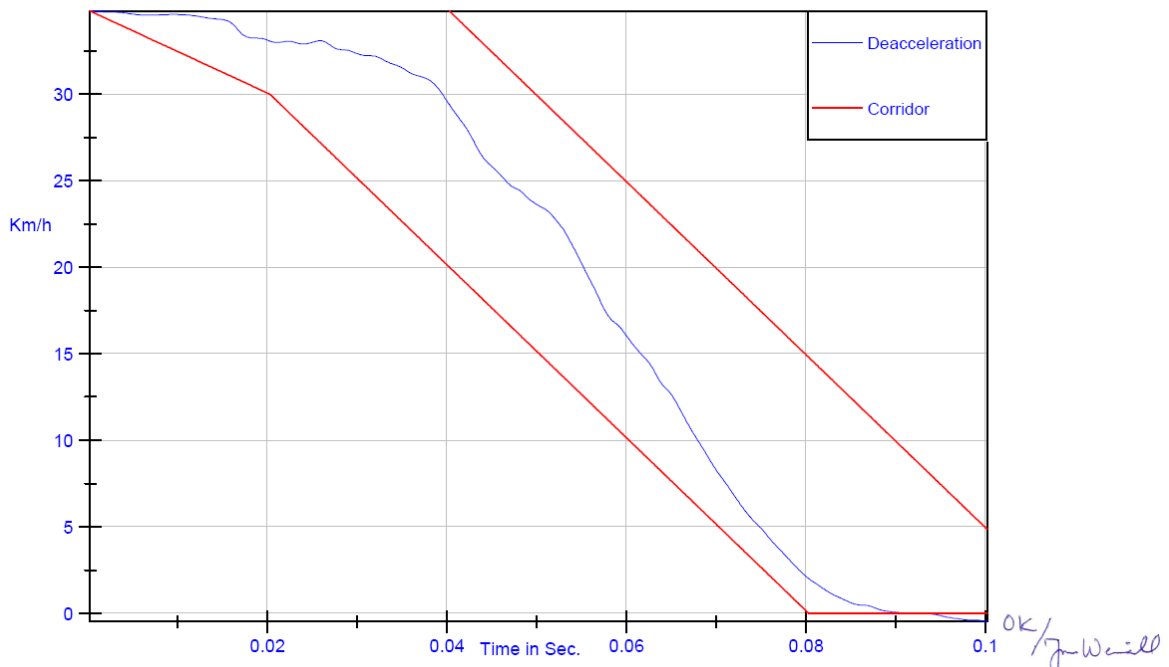
Deacceleration in calibration pole test EN 12767:2007

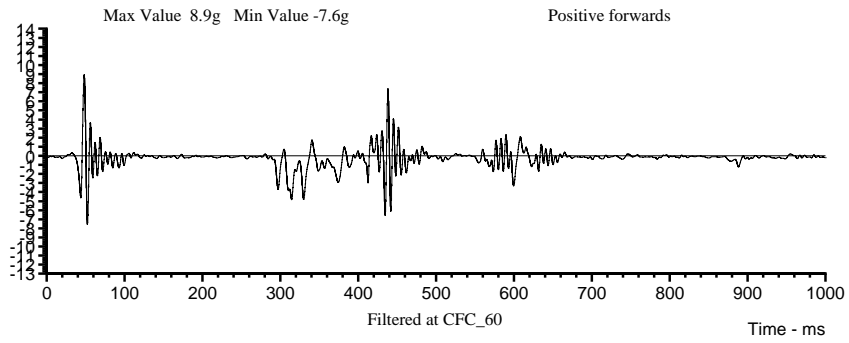
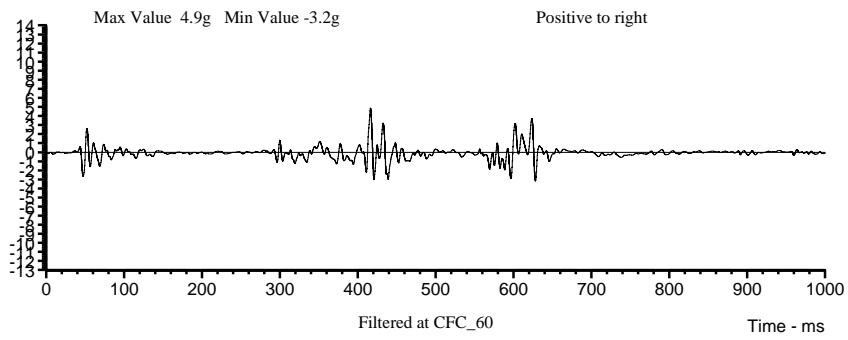
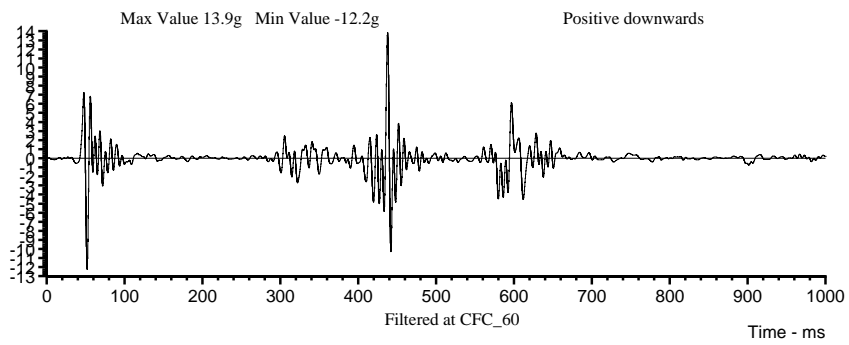
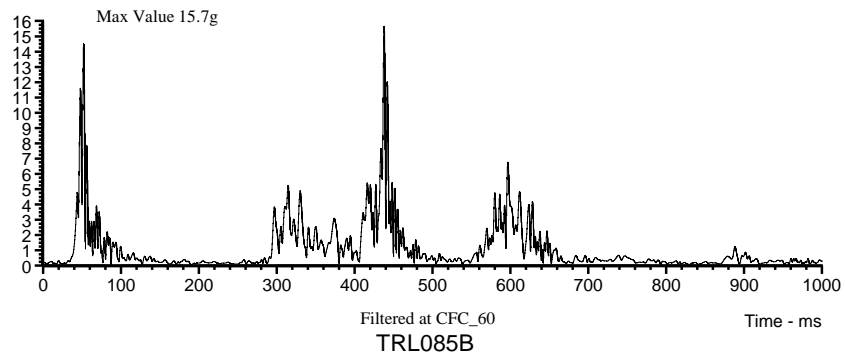
# 11 VEHICLE GRAPHS

Accelerometers were mounted on the rate sensor housing to measure acceleration in the X, Y, and Z directions. A second set of accelerometers measuring acceleration in the X, Y, and Z directions was mounted on the tunnel of the vehicle.

*Note: Failure of the rate sensors (Roll, Pitch and Yaw), so the graphs have not been included in this report.*
